AUDIT REPORT

ST COLUMB MAJOR CHAPEL
FORE STREET

ST COLUMB MAJOR

ON 10th SEPTEMBER 2018

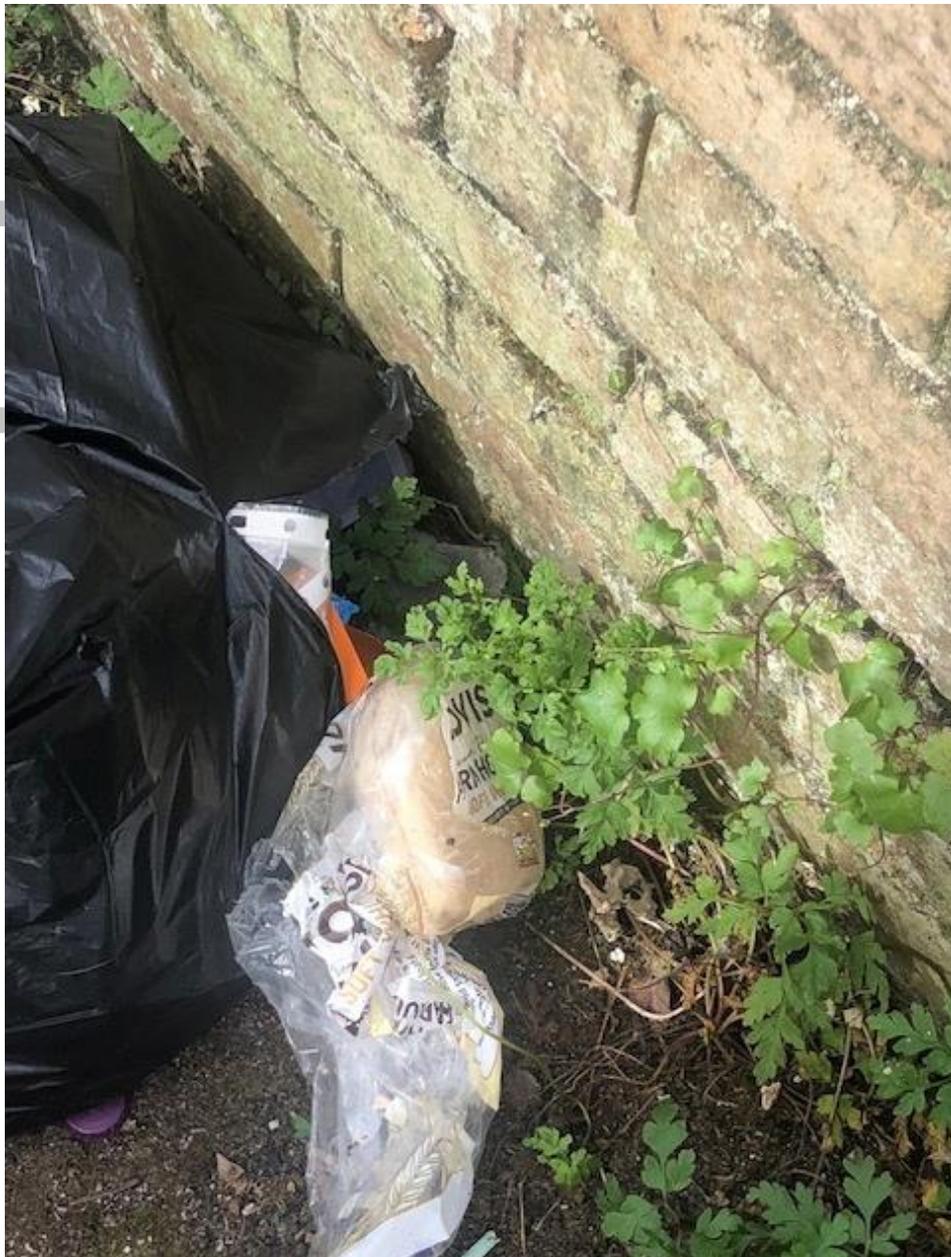
Rubbish & Waste

There are black bags of rubbish outside the main entrance into the hall; there is also evidence of food waste on the ground.

These items are likely to attract vermin with the risk of Weils Disease being present from infected rats.

The rubbish and food waste need to be cleared from the site as soon as possible to prevent the rats from getting inside and nesting for the winter months.

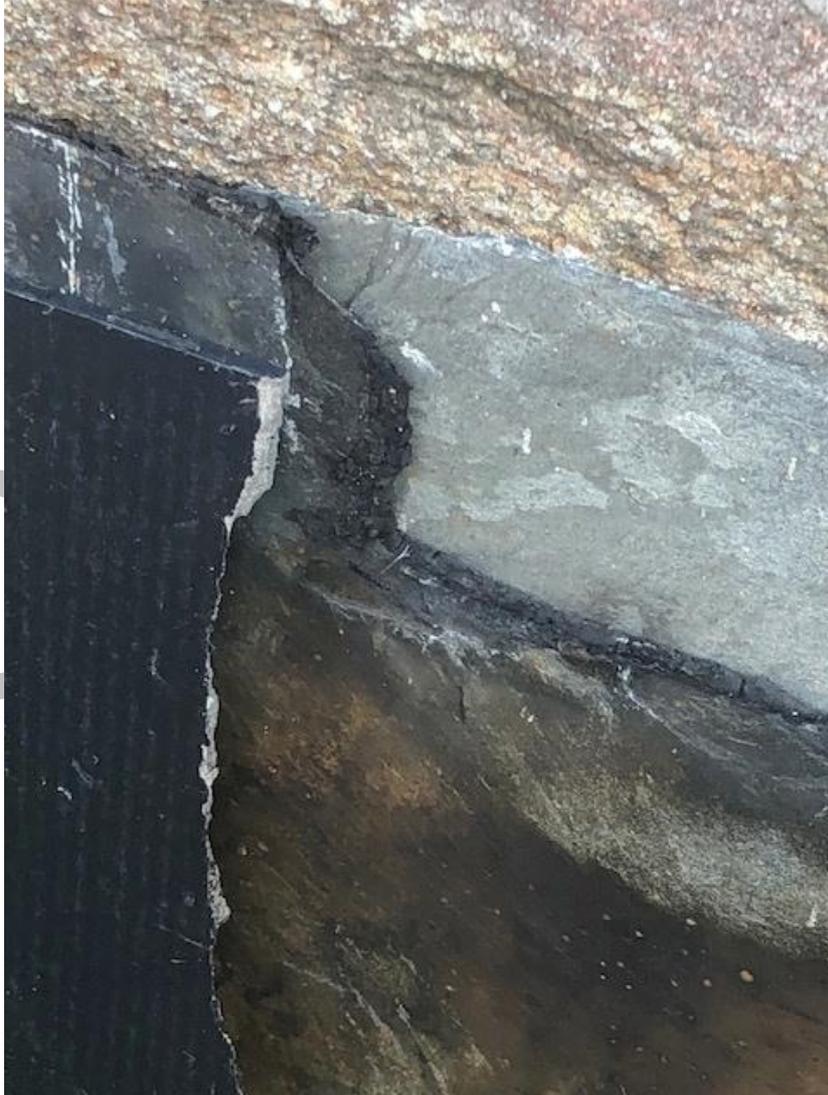
Asbestos slate

There is a broken piece of slate that appears to be asbestos-cement leaning against the external wall immediately outside the main door to the property.

This needs to be disposed of as hazardous waste in accordance with the Control of Asbestos Regulations 2002

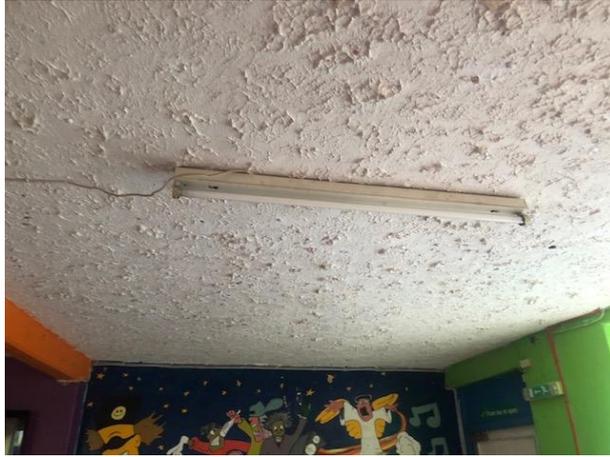
Asbestos-containing materials

In addition to the asbestos-cement tile seen outside the main door, there are other suspected materials within the structure that need to be checked. The artex ceiling is likely to contain asbestos, due to the age of the building and the likely period in which it was applied.

Asbestos is highly dangerous to the health of persons and so it is essential that these items are not disturbed when fibres are likely to be released

We suggest that an asbestos survey is undertaken to identify materials that contain asbestos so that a decision can be made as to how to manage the asbestos.

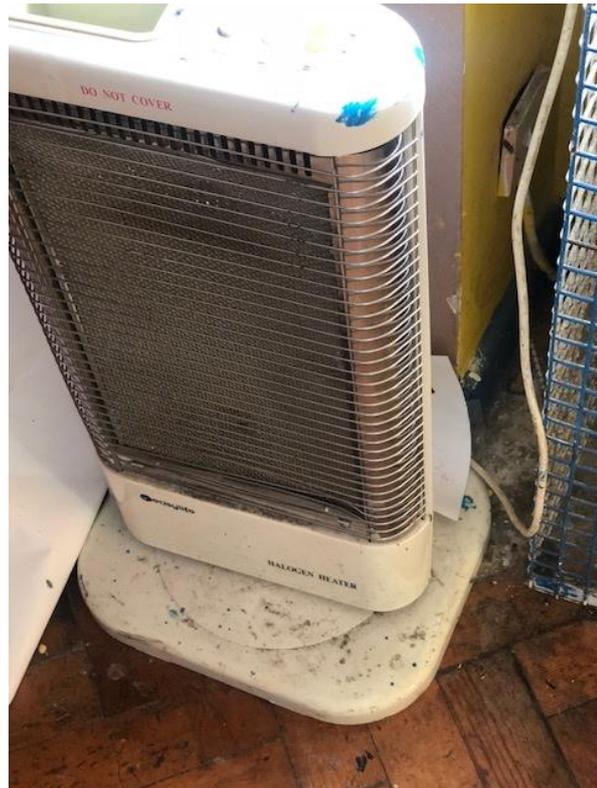
Electrical system and electrical appliances

There does not appear to be any recent tests or inspections on the main system or the appliances used within the youth club.

For example, the electric fire that is used in the bar area appears to be in poor condition

It is essential that regular checks are made to ensure that the equipment is in good condition and is safe to use.

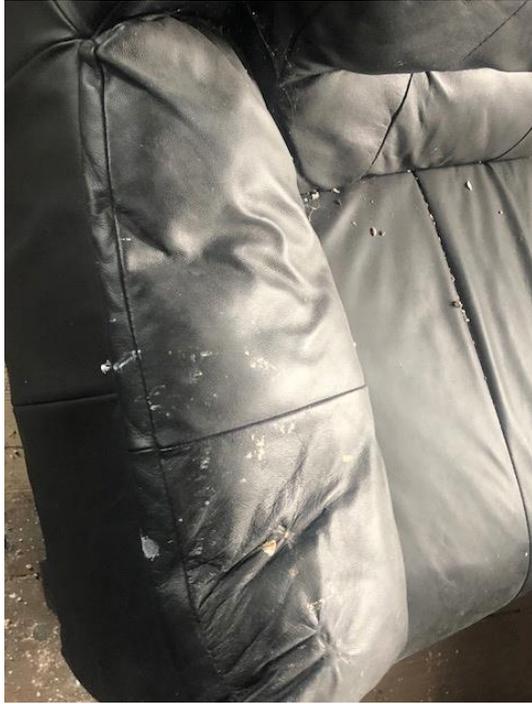
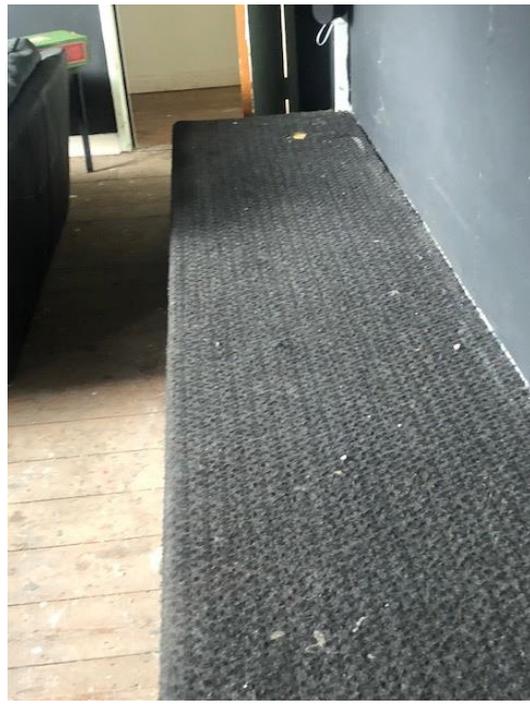
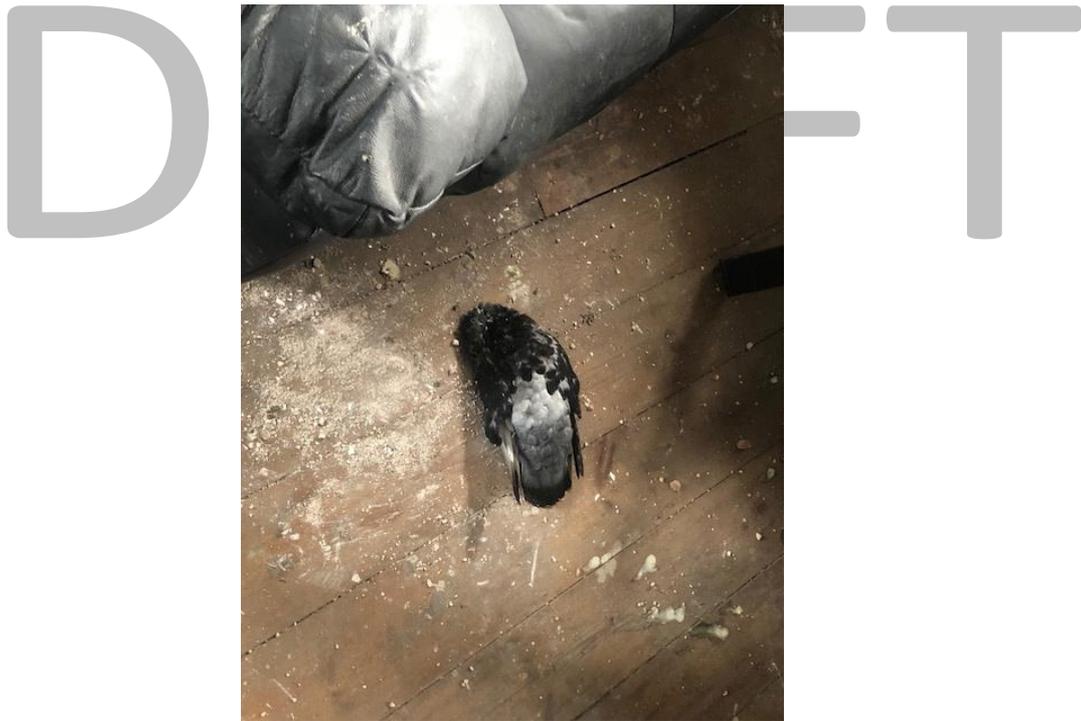
Pigeons

There is evidence that pigeons have been getting into the building. I understand from the Council that roofwork has been undertaken to repair holes and replace missing slates.

The furniture on the first floor shows signs of bird droppings and there is a dead pigeon in one of the first floor rooms.

Birds can cause health hazards in two ways –

- 1 Psittacosis is an illness caused by the dust from the birds wings that may contain various microscopic mites that are responsible for respiratory diseases
- 2 Guano (birds droppings) can contain formaldehyde that is a carcinogen

The building also needs a deep clean and sanitisation to ensure that the bird droppings have been removed completely and all surfaces are clean.
